BIG ELK LAKE DAM

(NDI I.D. PA-0056)

~~OWNER: MR. EDGAR SAKER~~  
Susquehanna River Basin, Elk Lake  
Stream, Susquehanna County, Pennsylvania  
PHASE I INSPECTION REPORT

PHASE I REPORT  
NATIONAL DAM INSPECTION PROGRAM

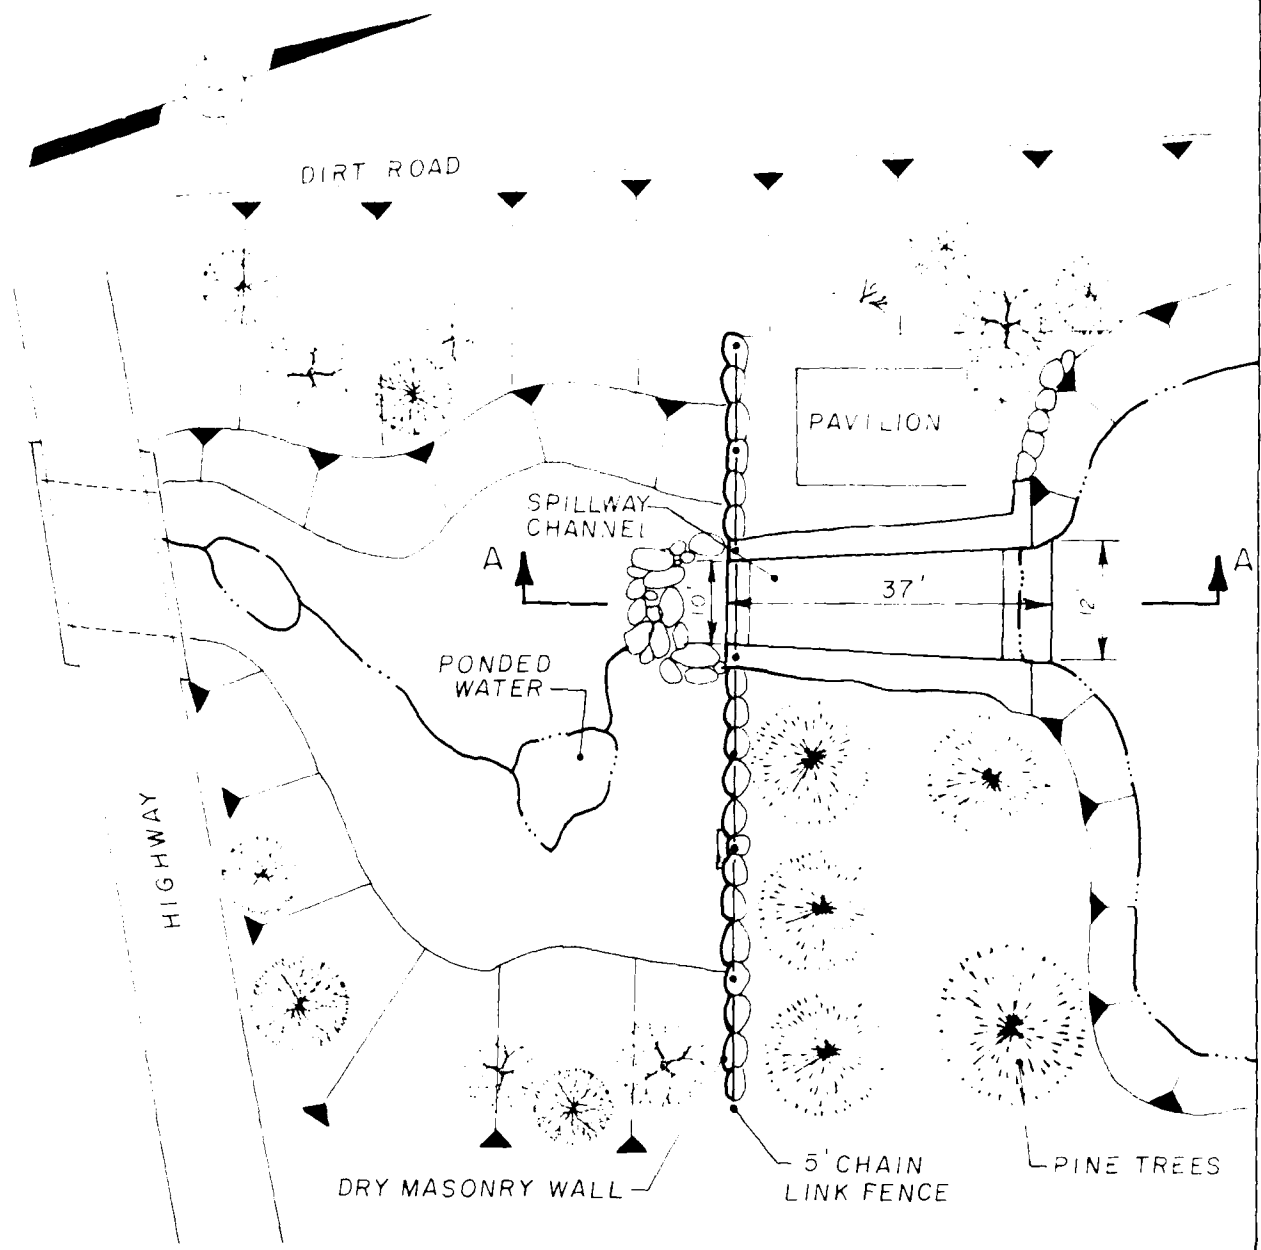
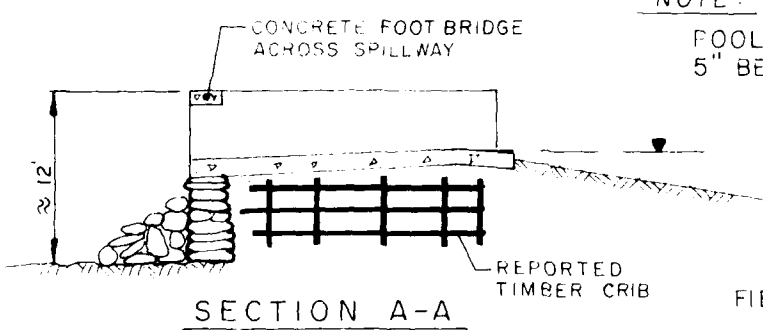
PLATE 2

The specific observations are illustrated in Plate 2.

In general, the condition of the dam is considered to be good. The crest of the dam is covered with a well-developed grass cover and some pine trees. The upstream face of the dam is also covered with grass and was found to be in good condition with no signs of significant shoreline erosion. The dry masonry wall was found to be in good condition; no signs of bulging or other structural distress were noted.

c. Appurtenant Structures. The spillway structure was examined for deterioration or other signs of distress that would limit flow. In general, the spillway structure which consists of a concrete overflow channel was found to be in good condition. An opening was observed at the toe of the stone wall which may be the low level outlet culvert referred to in the 1915 state report.

POOL LEVEL AT DATE OF INSPECTION  
5" BELOW SPILLWAY CREST
